# Urban Forestry Services, Inc.

Title: Kemp Hiatt Property Tree Assessment  
8800 Paisley Place NE,  
8415 Inverness Drive NE,  
Seattle, Washington

Prepared for: CG Engineering  
Attn: Carmel Gregory  
250 4<sup>th</sup> Ave S. Suite 200  
Edmonds, 98020

Date: January 15, 2018

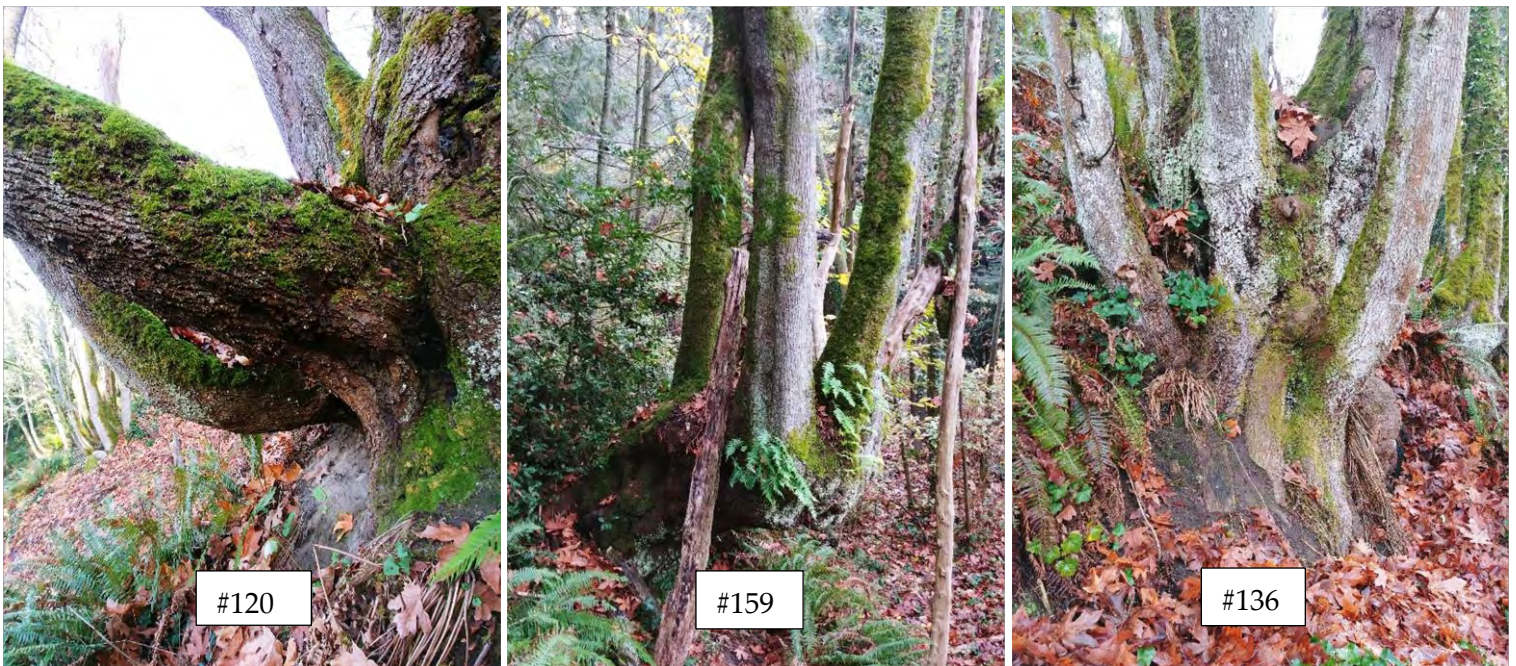
These large Big leaf maples, *Acer macrophyllum* (#'s 112, 120, 132, 135, 136, and 159); and Western red cedars, *Thuja plicata* (#126, and #160) are within steep slope critical areas and should be retained for slope stability. These trees have varying retention values. Though exceptional by size all these trees show signs of decay at the base, unusual rooting and lower trunk shapes, and overall poor vigor.

Most of these trees have a high risk of failure and will require extensive maintenance or removal to improve safety if they are located near the new building. Level 3 Tree Risk

**Photo 1-3. Many Exceptional multi-stem maples reside on the steep slope. Many of these trees are not in good condition. Preservation of these trees with unique structure is dependent on development plans. These trees will be a high risk to new buildings located within their falling zone if maintenance is not conducted. Level 3 Tree Risk assessments are recommended for any trees being retained.**

Assessments focusing on trunk strength and root distribution are recommended for any retained exceptional trees prior to building around them.

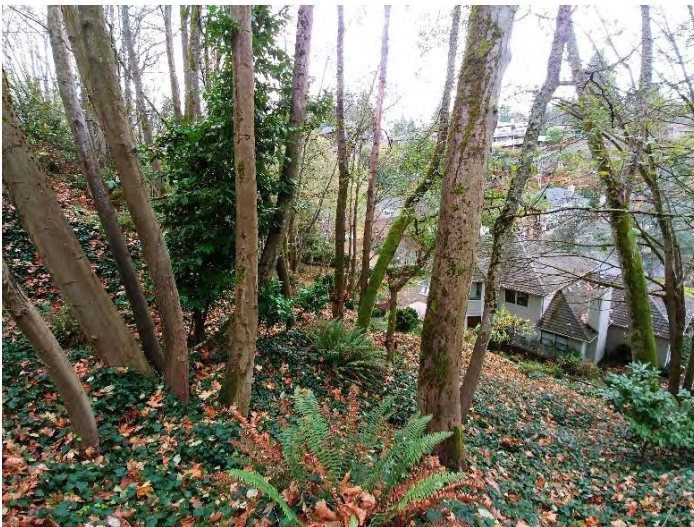
**Photo 4.** This is the northwest corner of the property looking down hill toward neighboring trees and house. Trees below the laurel are on the adjacent private property.

These trees are recommended for immediate removal or reduction to create a small habitat snag. Trees #104, 105, 107, 113, and 114 are located on the north west hill side, and trees #148-150, 154, and 155 are within the wetland along the south west property border. All trees are marked with a low or no retention value symbol on the map. These trees have poor health and structure and are large enough to impact neighboring houses if they fail.

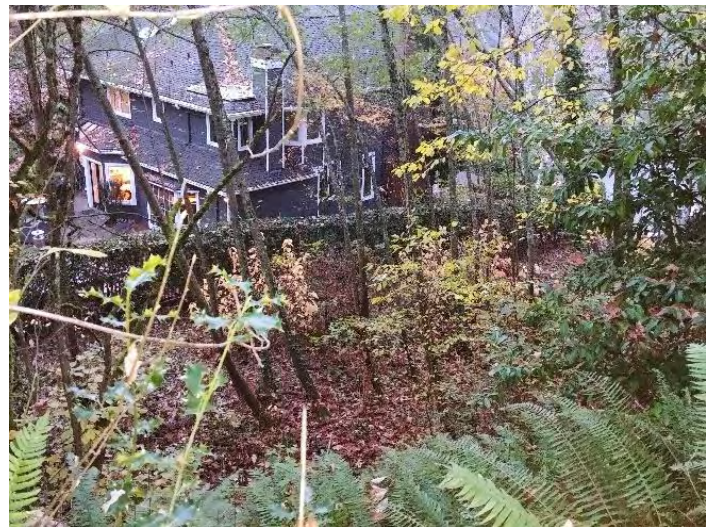
**Photo 5.** These are alder trees within the riparian wetland. These tall skinny trees have a high probability of failing. Some may strike the neighboring property.
